Building Inspection Report

123 Sample Ave., Blue Tuna, PA 15555

Inspection Date:
01-01-2009

Report Number:
B2009403

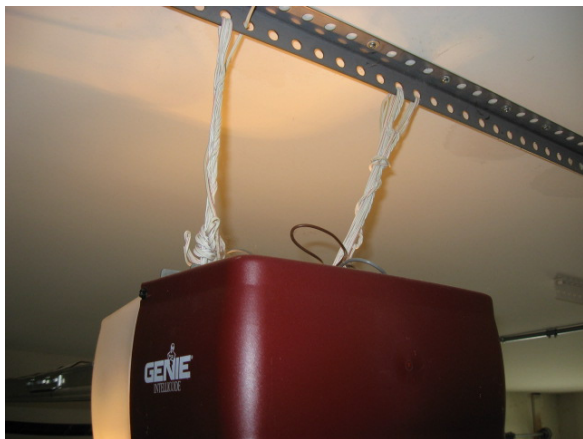
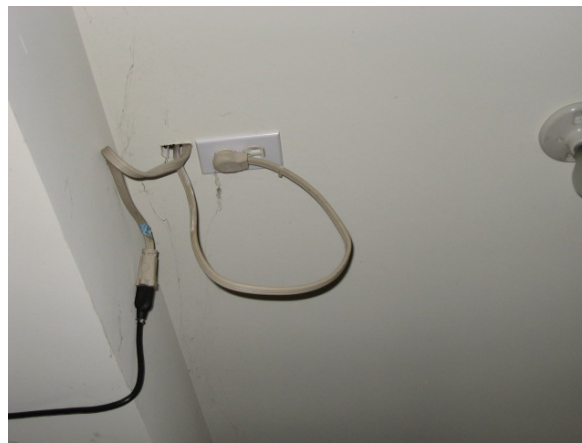
- One garage door has an automatic opener installed. It appears to be a non-professional installation. The motor is attached to the ceiling with wire and connected to an extension cord. Additionally, the pressure safety reverse did not respond. Recommend the opener be installed properly by a qualified individual.

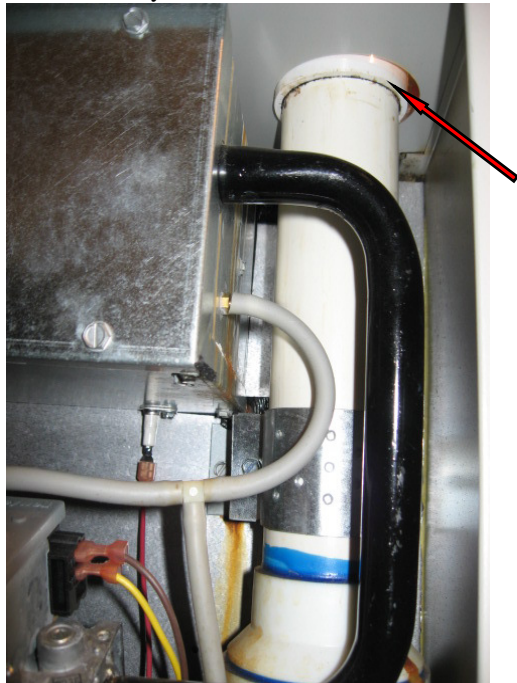
The indicated area was wet and there was no evidence of PVC cement at the coupling.

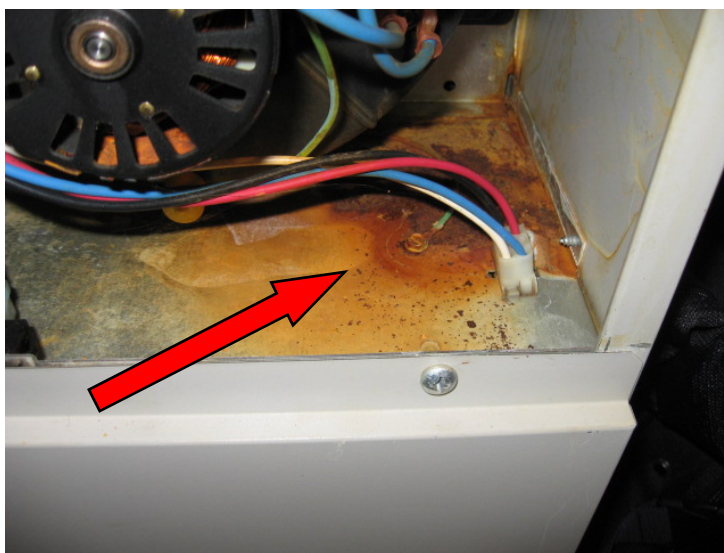
There is heavy corrosion in the furnace and in the return air duct to the unit.

The interior of the furnace exhibits unusually heavy corrosion, given the age of the unit. (about 4 years old)

- **Repair:** The heating system requires service. This should be a regular maintenance item to assure safe, reliable heat.

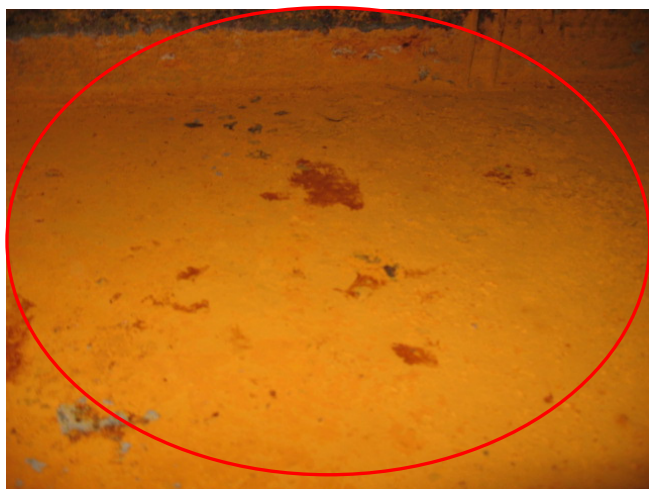
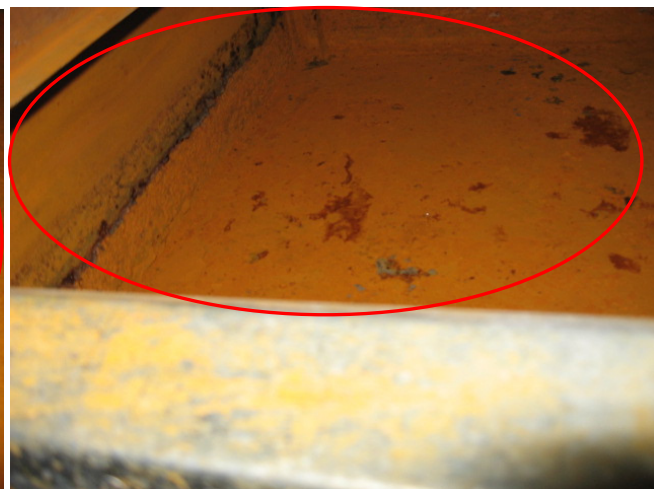
This is the cold air return as seen from the filter change area under the furnace. Heavy corrosion is present and should be addressed by a qualified HVAC technician. The unit should be serviced at regular intervals.

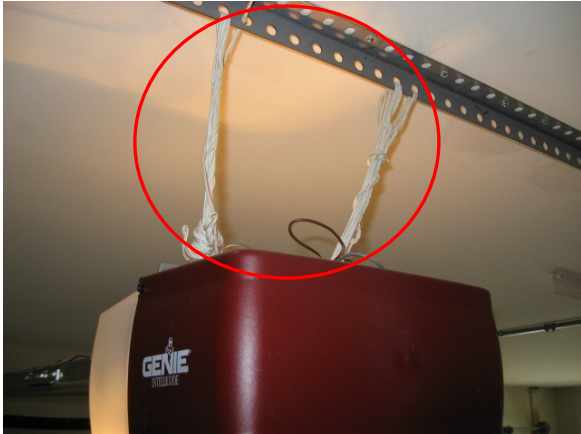
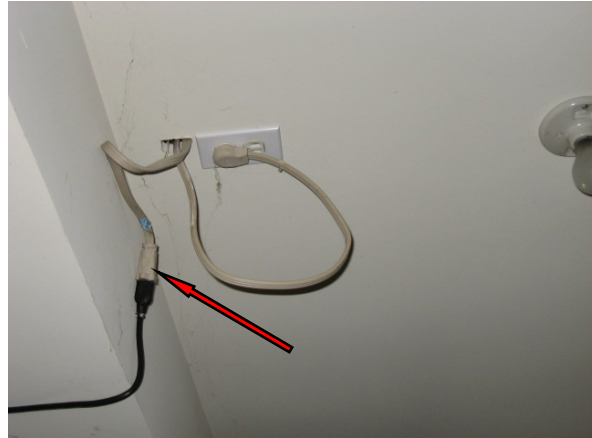
- One garage door has an automatic opener installed. It appears to be a non-professional installation. The motor is attached to the ceiling with wire and attached to an extension cord. Additionally, the pressure safety reverse did not respond. Recommend the opener be installed properly by a qualified individual.

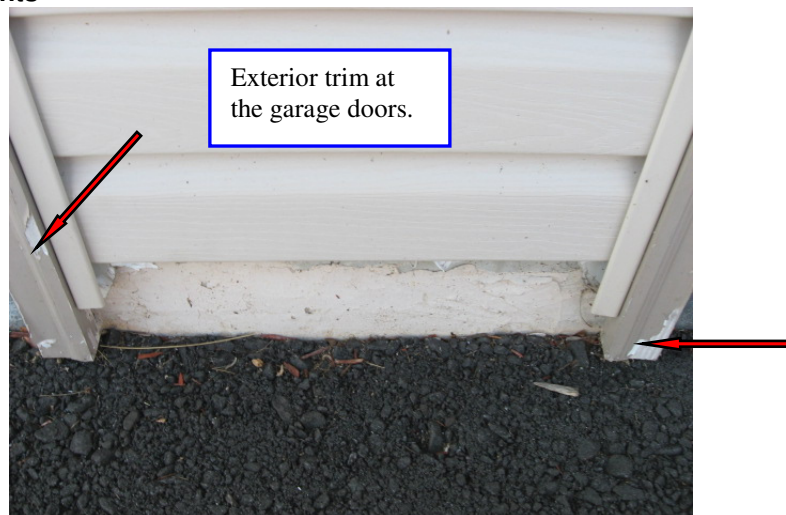
- The exterior trim has peeling paint. Recommend removing loose paint and priming and painting of all exterior trim as needed.
- The installation of ground fault circuit interrupter (GFCI) devices is advisable for enhanced safety in the mechanical equipment room and the basement powder room.

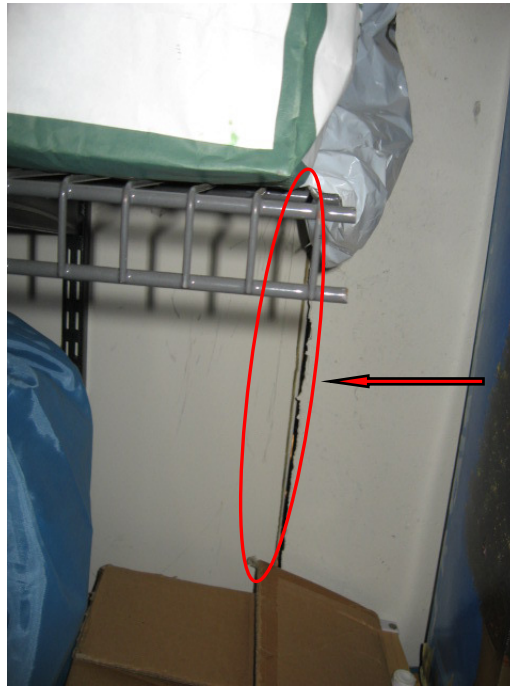
- The side rear garage wall has visible daylight at this unsealed gap between the concrete and framed sections of wall.

- Garage – Recommend sealing all gaps between interior and exterior to prevent water, insect and vermin intrusion.

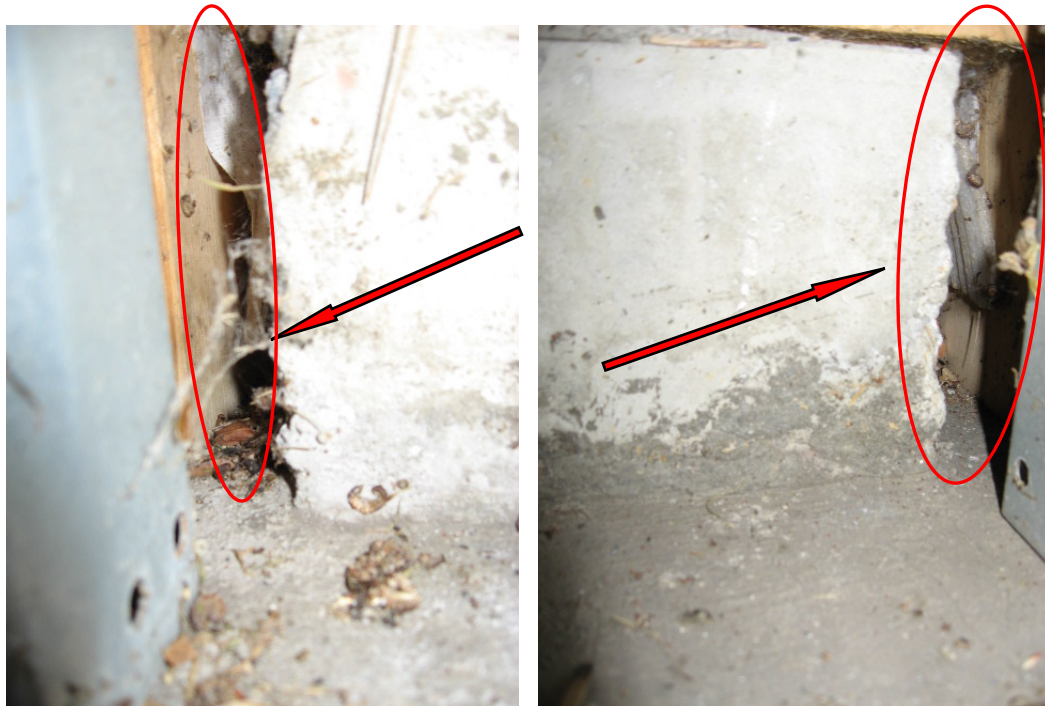
- These gaps beside each garage door should be sealed to prevent water, insect and vermin intrusion.
- Recommend installing a CO detector for enhanced safety.

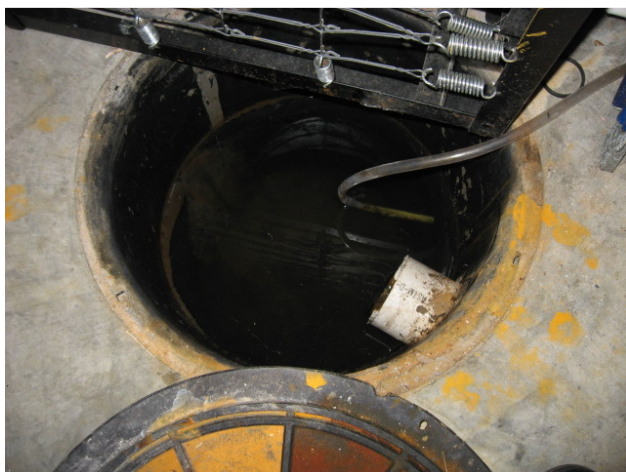
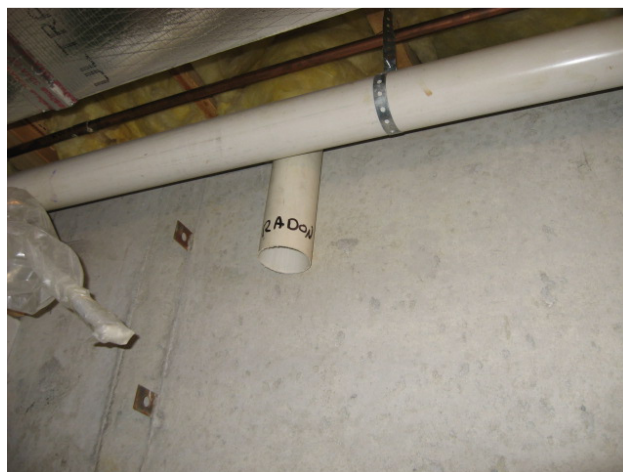
- There is no sump pump installed into the sump pit. There is standing water in the pit. Recommend a qualified professional install a sump pump and associated piping. Additionally, there is a radon remediation system exhaust pipe above the sump pit that should be capped to prevent drafting, if it is not utilized.

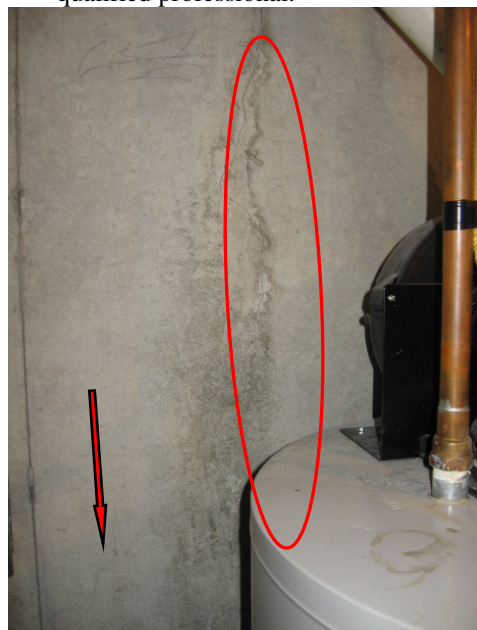
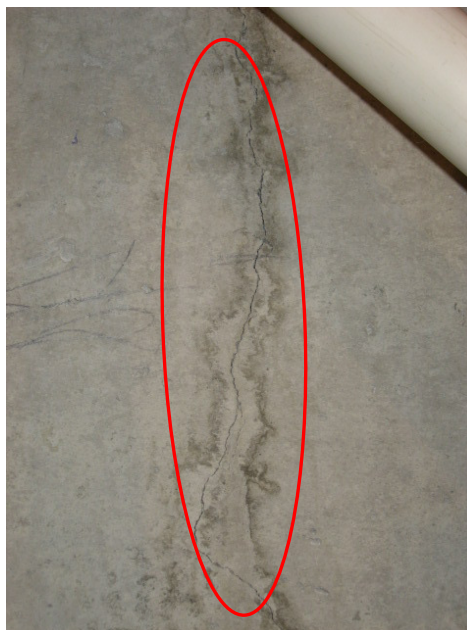
- **Monitor:** Minor vertical cracks were observed in the foundation. This type and pattern of cracking is usually the result of concrete shrinkage as it cures. Shrinkage cracks are very common and are not normally a concern.
- **Monitor:** A long vertical crack was observed in the area behind the water heater as indicated inside the oval. A smaller typical shrinkage crack was observed adjacent to this area and is indicated by the arrow. The long crack propagates on both sides of the L.P. gas entrance hole. There was no indication of active movement or wall displacement. There is staining from previous moisture penetration. This area should be monitored for future evidence of moisture intrusion or significant movement (<math><3/8''</math> crack width or any wall displacement) and corrective action taken as determined by a qualified professional.

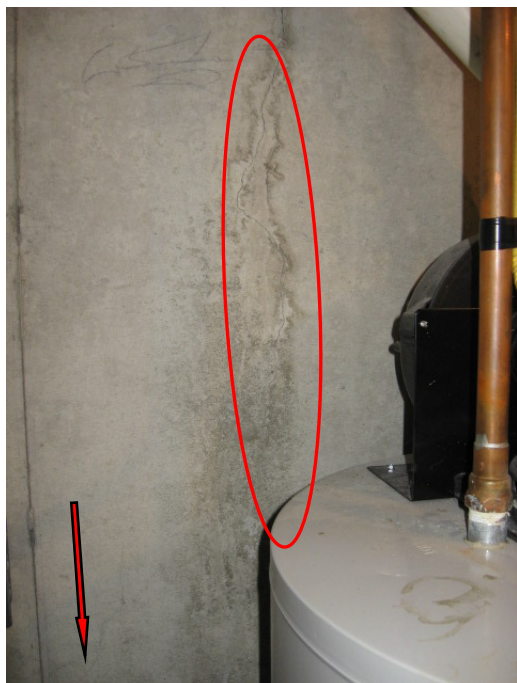
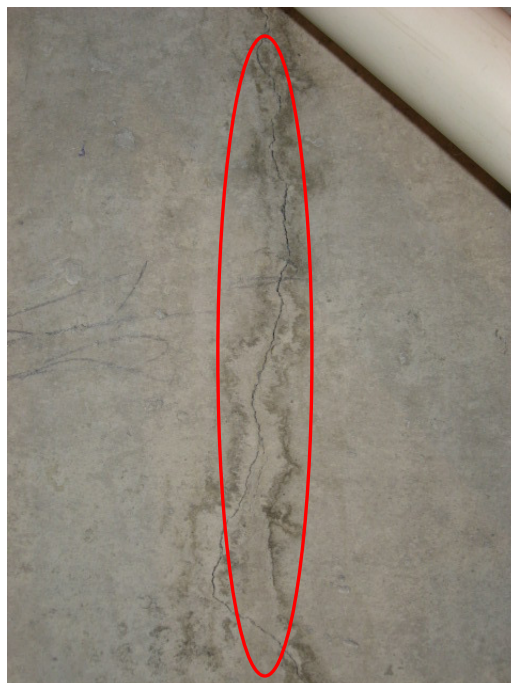
- **Monitor:** Minor vertical cracks were observed in the foundation. This type and pattern of cracking is usually the result of concrete shrinkage as it cures. Shrinkage cracks are very common and are not normally a concern.

A long vertical crack was observed in the area behind the water heater as indicated inside the oval. A smaller typical shrinkage crack was observed adjacent to this area and is indicated by the arrow. The long crack propagates on both sides of the L.P. gas entrance hole. There was no indication of active movement or wall displacement. There is staining from previous moisture penetration. This area should be monitored for future evidence of moisture intrusion or significant movement (<math><3/8\text{''}</math> crack width or any wall displacement) and corrective action taken as determined by a qualified professional.

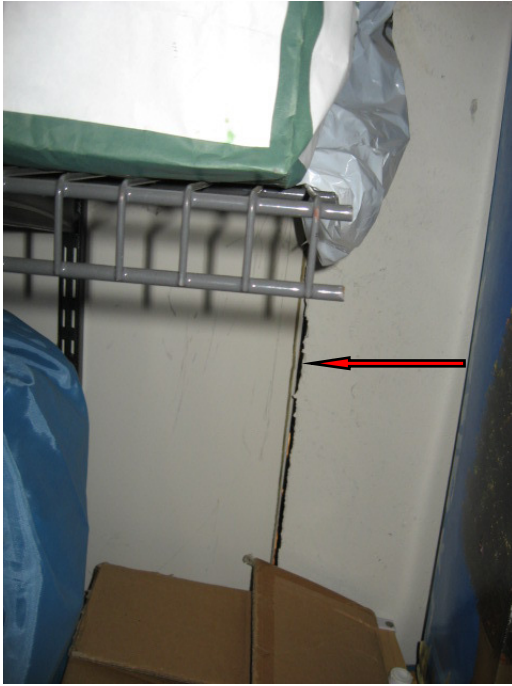
The side rear garage wall has visible daylight at this unsealed gap between the concrete and framed sections of wall.

- Garage – Recommend sealing all gaps between interior and exterior to prevent water, insect and vermin intrusion.

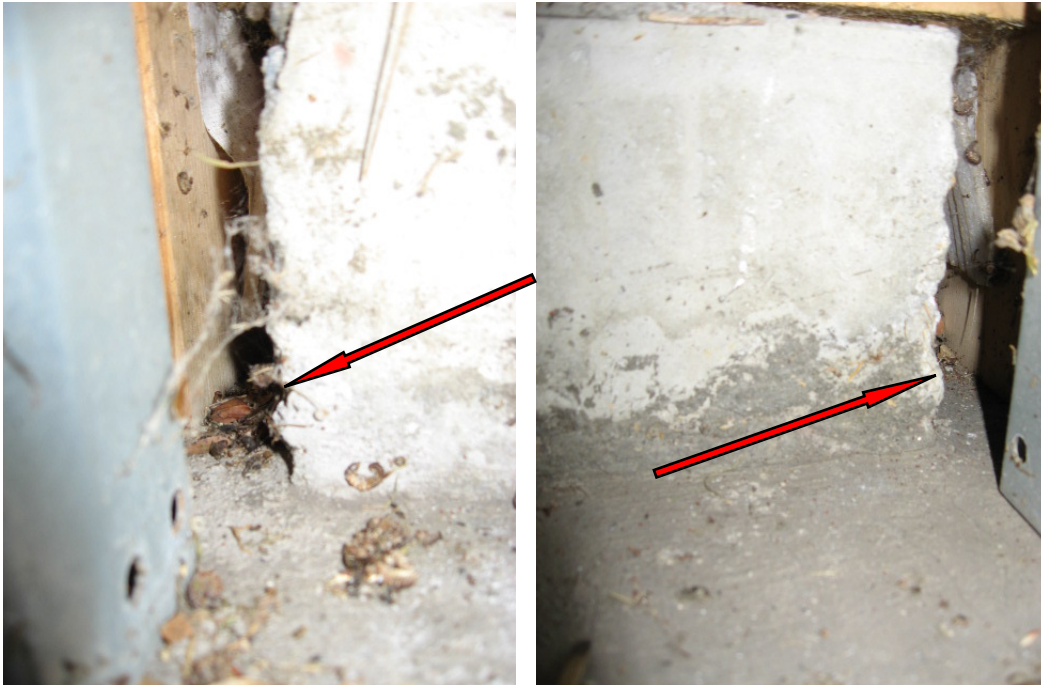
These gaps beside each garage door should be sealed to prevent water, insect and vermin intrusion.
